Service Slants

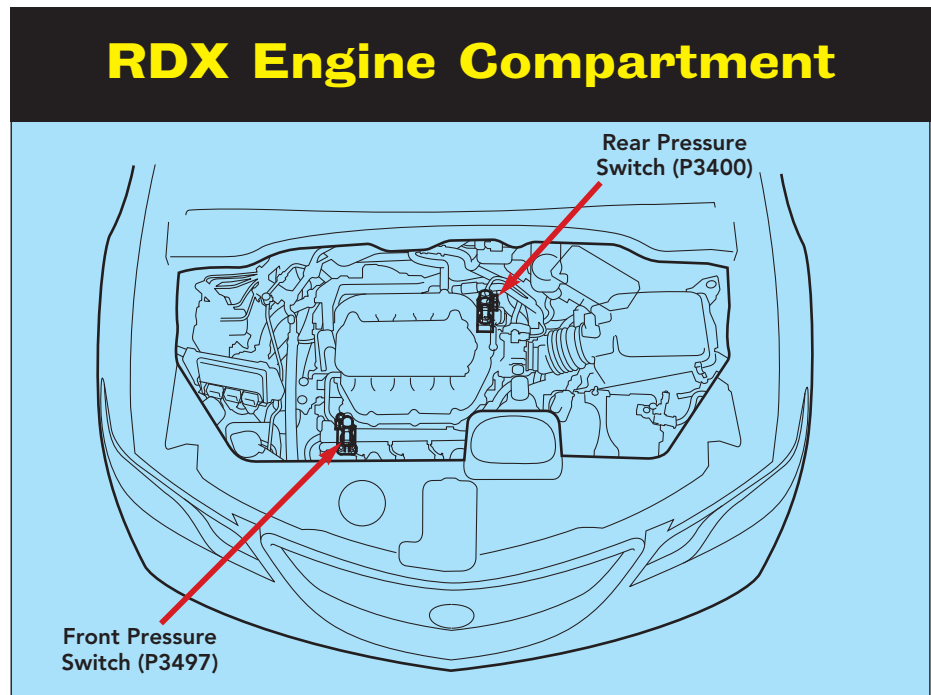
Some 2013 2WD RDX trucks built from VINs 5J8TB3...DL000001 through 5J8TB3...DL006466, as well as 4WD models built from VINs 5J8TB4...DL000001 through 5J8TB4...DL009205, may intermittently illuminate the MIL and log Valve Pause System (VPS) codes P3400 and/or P3497 in the PCM. One probable cause of the trouble, reports Acura, is a sticking rocker arm oil pressure switch on one or both banks of the engine. Installing a new-design pressure switch and O-ring (Part Nos. 37240-R70-A04 and 91319-PAA-A01, respectively) should eliminate further trouble.

Before ordering the new parts, however, check the engine oil dipstick, because a low oil level will definitely cause the VPS to go haywire and store the DTC(s) noted. If the oil level is low, add oil, clear the code(s) and release the vehicle to the customer. If the oil level is on the money or the truck comes back with the same complaint, go ahead and replace the front and/or rear pressure switch and O-ring, depending on the code(s) logged. The location of each rocker arm oil pressure switch and its respective DTC is shown in the accompanying illustration.
